Manhole Inspection Summary

Manhole # S21A__038MH

Inspection ☐ Is Incomplete Rating: **4) Poor**

Location Address: **624 MOUNT ST**

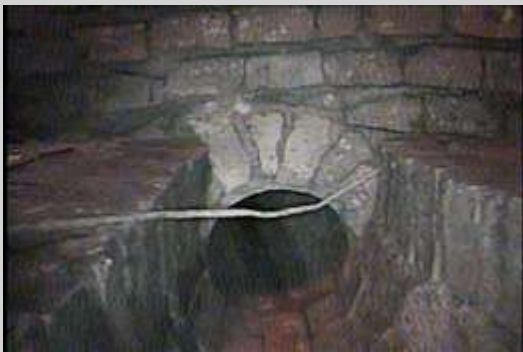
12 O'Clock Outflow

Pipe Height: **8.4** (in.) Rod and Bar (Angled)
Pipe Material: **Clay** ☐ Pipe Lined
Invert Depth: **8.74** (ft.) Flow Characteristics: **None**
Deposits: ☒ None ☐ Mud ☐ Sludge ☐ Debris ☐ Grease
Silt Depth: (in.) Deposits Extent:
Infiltration: **None** Pipe Seal Cond: **Sound**

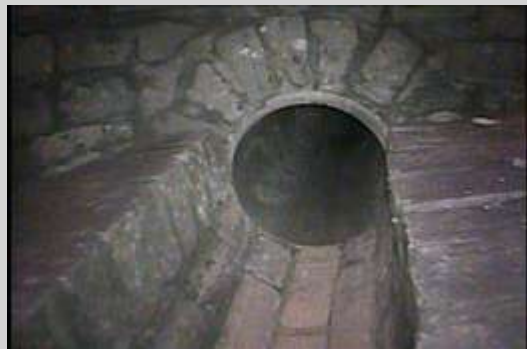
6 O'Clock Inflow

Pipe Height: **8.4** (in.) Rod and Bar (Angled)

Infiltration: **None** Pipe Seal Cond: **Sound**
